Property Inspection Report
For Irene Calzadilla
Managed Assets Division
June 9, 2014

12 W. Jackson Street
Joliet, IL

MAD Property Inspection Report

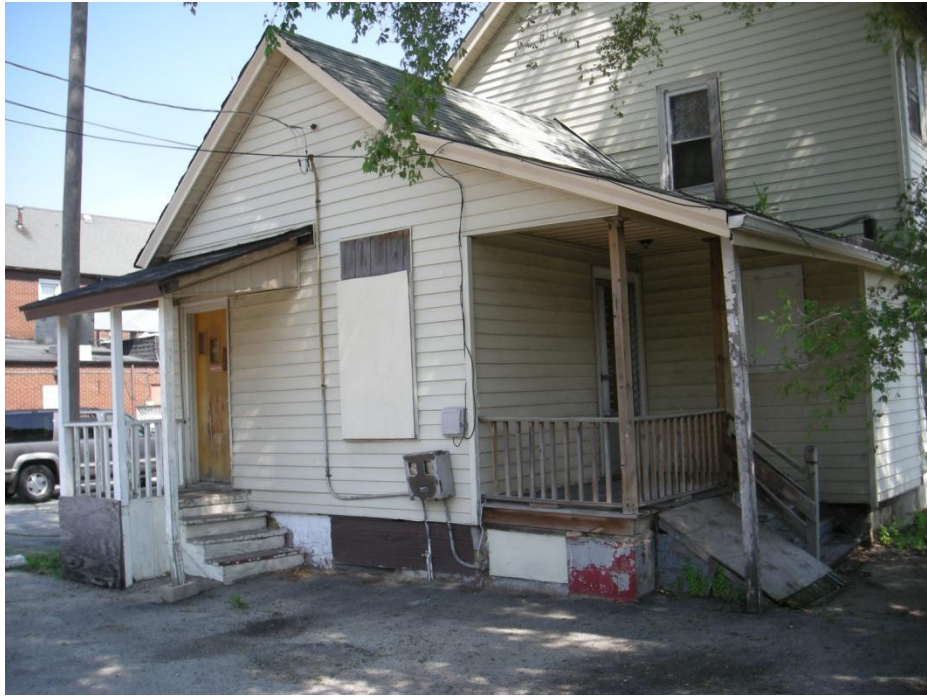
West elevation and south entrance to second floor unit

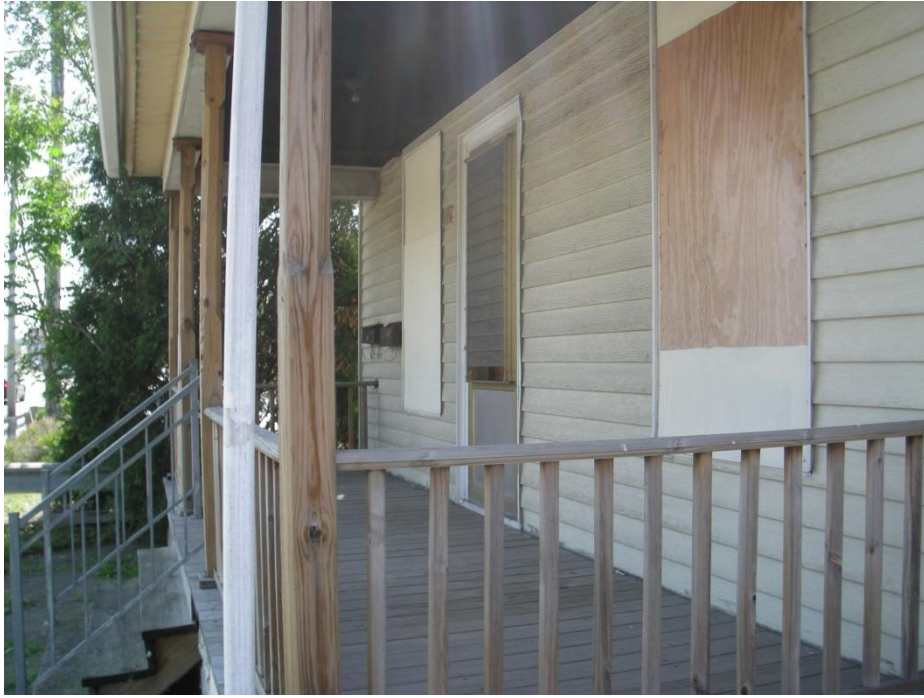
Site secure

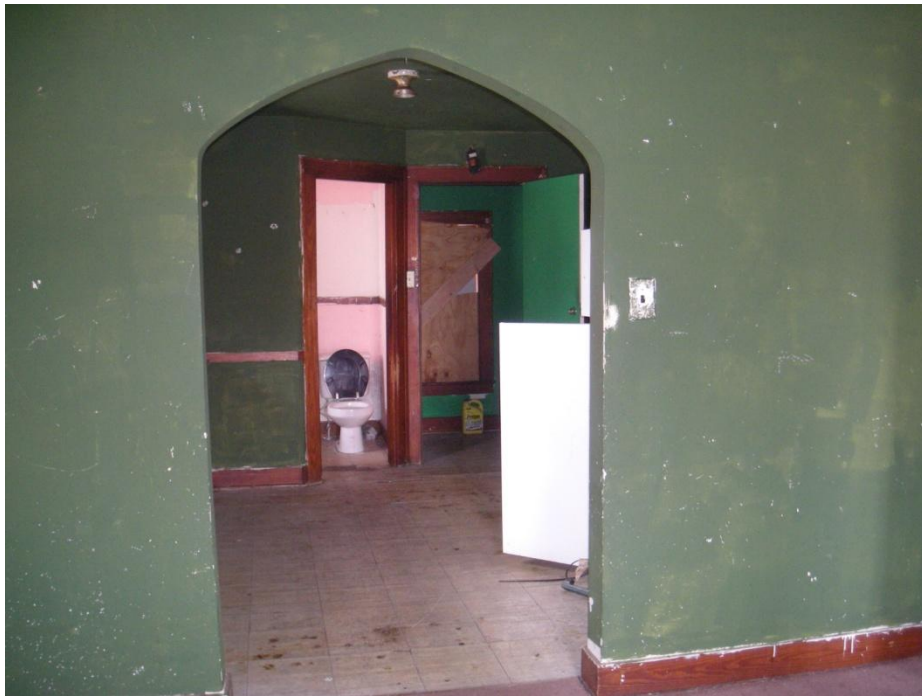
No changes to interior

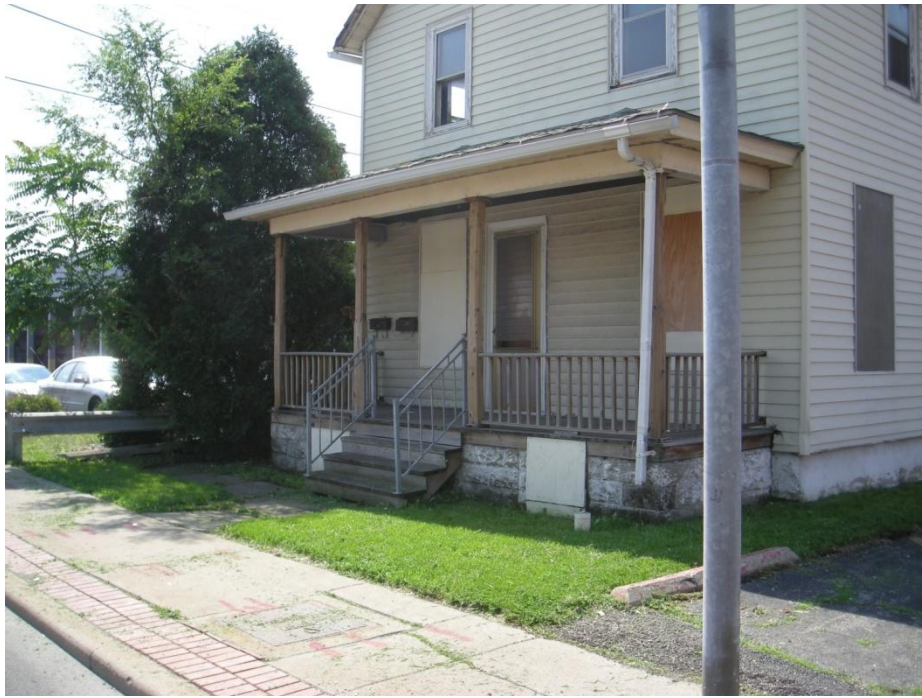
Grass cut and debris picked up
