# Inspection Report

## 1727 Dayton,LLC

**Property Address:**  
1727 N Dayton  
Chicago IL 60614

<b>Date:</b> 5/13/2013	<b>Time:</b> 10:30 AM	<b>Report ID:</b> 2013-5-13-1
<b>Property:</b> 1727 N Dayton Chicago IL 60614	<b>Customer:</b> 1727 Dayton,LLC	<b>Real Estate Professional:</b> Pat Cullen Conlon and Company

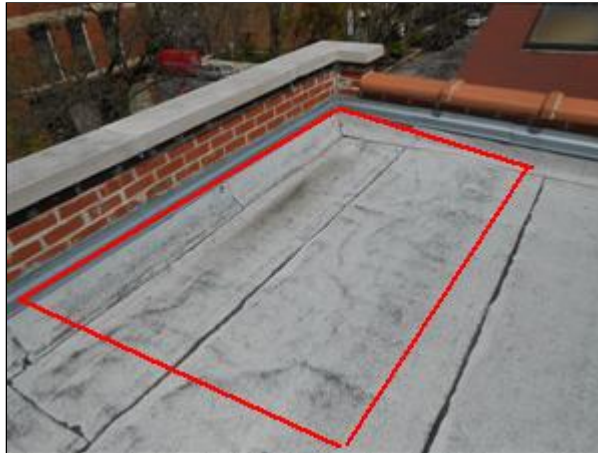
1.0 Picture 1

**1.0** The flat roof underlayment is loose at the north west corner of the roof. Roof sheathing needs to be replaced or repaired in this area. This will involve some shingle replacement. A qualified roofer should inspect and repair as needed.

The flat roof underlayment is loose at the north west corner of the roof. Roof sheathing needs to be replaced or repaired in this area. This will involve some shingle replacement. A qualified roofer should inspect and repair as needed.

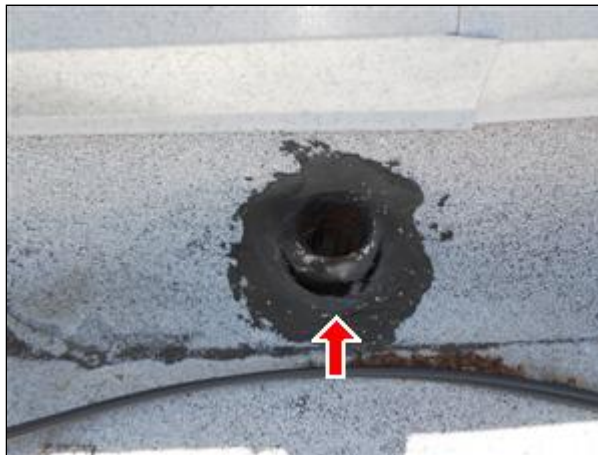
1.1 Picture 1

**1.1** The kitchen vent is not sealed properly and not high enough on the roof. This can allow water to enter the roof and cause damage. We recommend that a licensed roofer review and repair as needed.

The kitchen vent is not sealed properly and not high enough on the roof. This can allow water to enter the roof and cause damage. We recommend that a licensed roofer review and repair as needed.

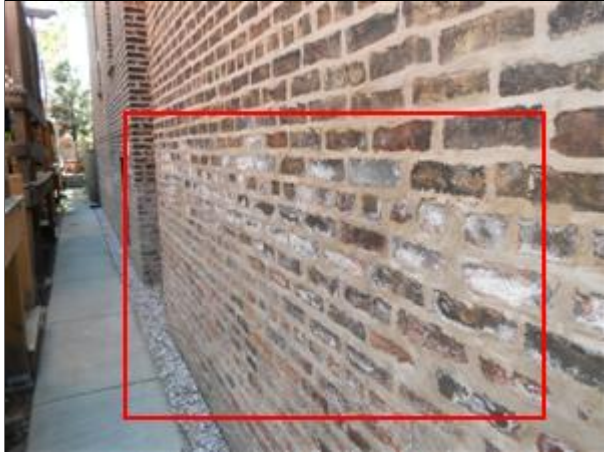
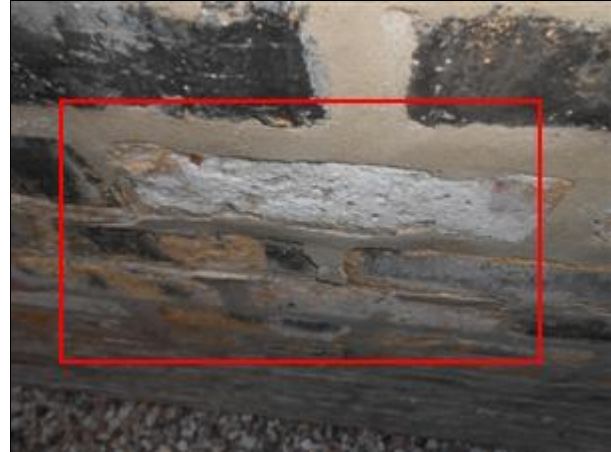
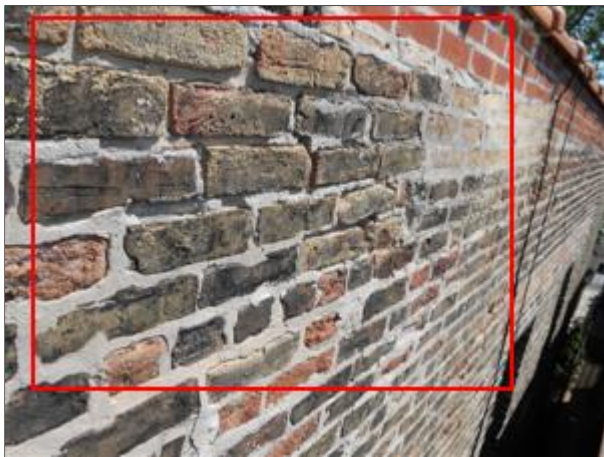
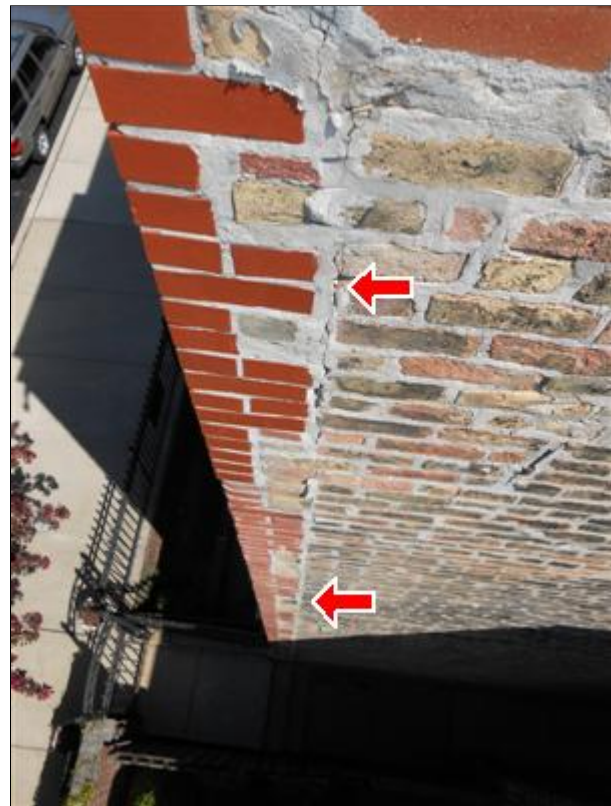
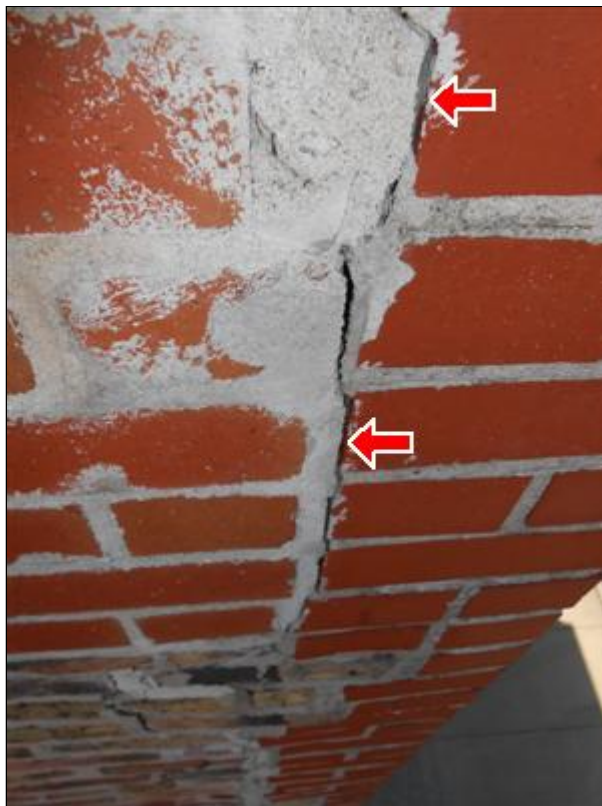
**2.0** The home is in need of tuck pointing at the front rear and sides of the home. Tuck pointing will stop water from entering the home and causing damage. We recommend that a qualified contractor review and repair as needed.

The home is in need of tuck pointing at the front rear and sides of the home. Tuck pointing will stop water from entering the home and causing damage. We recommend that a qualified contractor review and repair as needed.

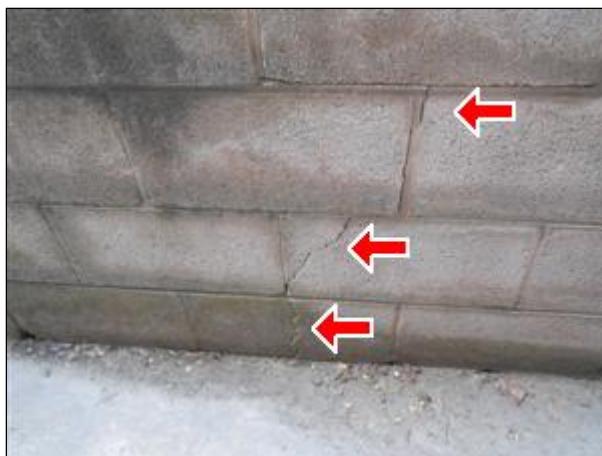
2.4 Picture 1

**2.4 (1)** The brick retaining wall at the front of home is leaning and erosion signs are present. This problem will continue to become worse and needs correcting. Further deterioration may occur if not repaired. A skilled masonry contractor should perform the work.

(1) The brick retaining wall at the front of home is leaning and erosion signs are present. This problem will continue to become worse and needs correcting. Further deterioration may occur if not repaired. A skilled masonry contractor should perform the work.

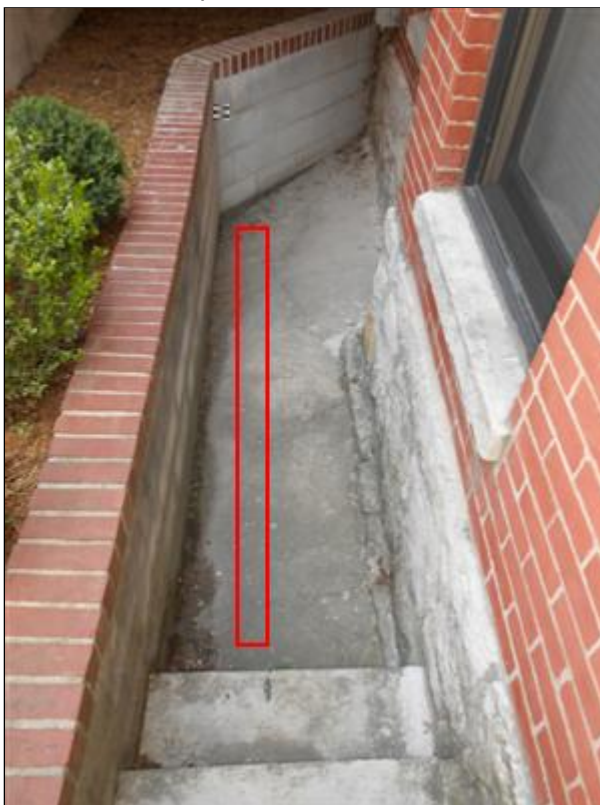
2.4 Picture 2

(2) The front lower walk is missing a drain. This can allow water to pool and access the basement and cause damage. We recommend that a qualified contractor review and repair as needed.

(2) The front lower walk is missing a drain. This can allow water to pool and access the basement and cause damage. We recommend that a qualified contractor review and repair as needed.

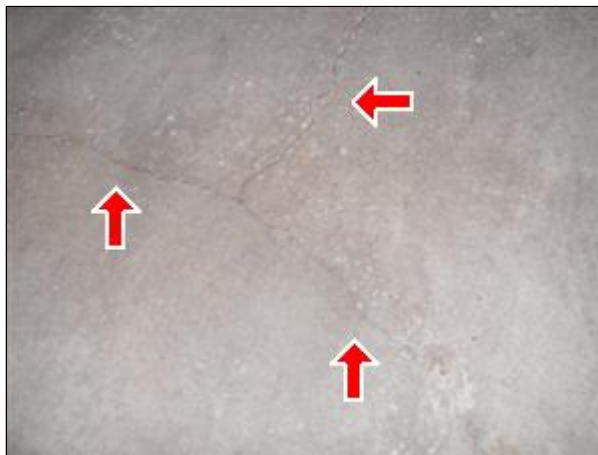
3.3 Picture 1

**3.3** The concrete floor of garage is cracked in areas. These cracks do not appear significant and seem typical.

The concrete floor of garage is cracked in areas. These cracks do not appear significant and seem typical.

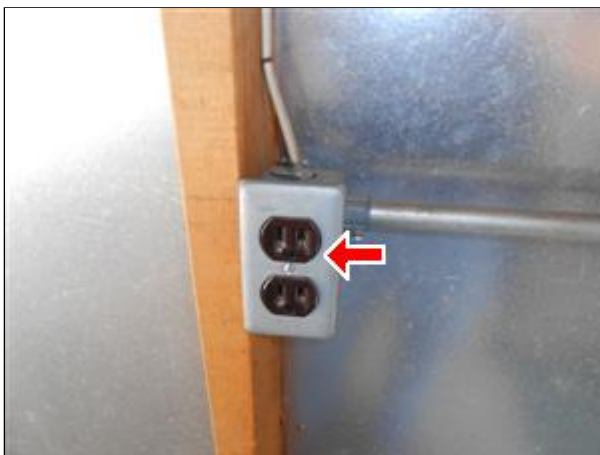
3.8 Picture 1

**3.8 (1)** At least two "three-prong" outlets are outdated and not a three-prong GFCI (Ground Fault Circuit Interrupt) in the garage. This is a safety issue that needs to be corrected. A qualified licensed electrical contractor should correct as needed.

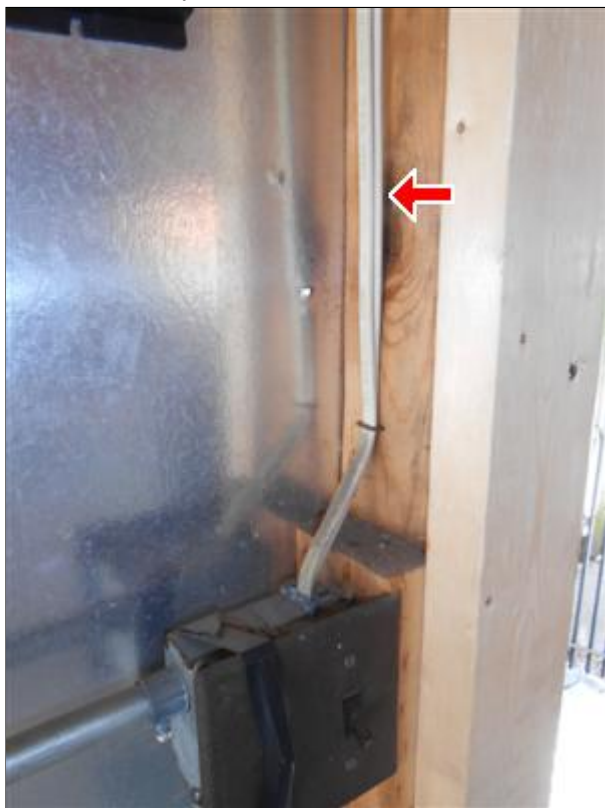
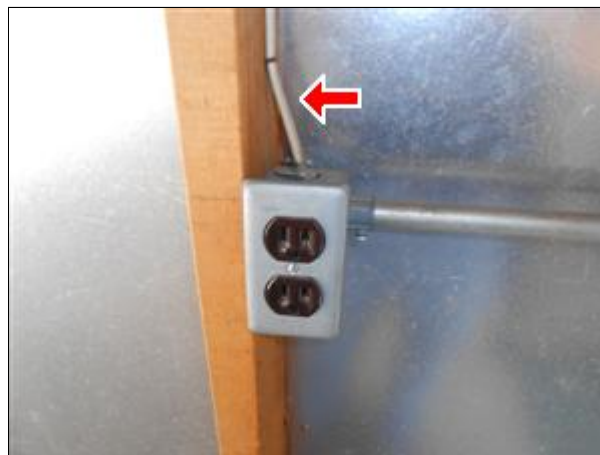
**(2)** Romex wiring was found in the garage. Romex wiring is not allowed in Chicago. We recommend that a licensed electrician review and repair as needed.

(2) Romex wiring was found in the garage. Romex wiring is not allowed in Chicago. We recommend that a licensed electrician review and repair as needed.

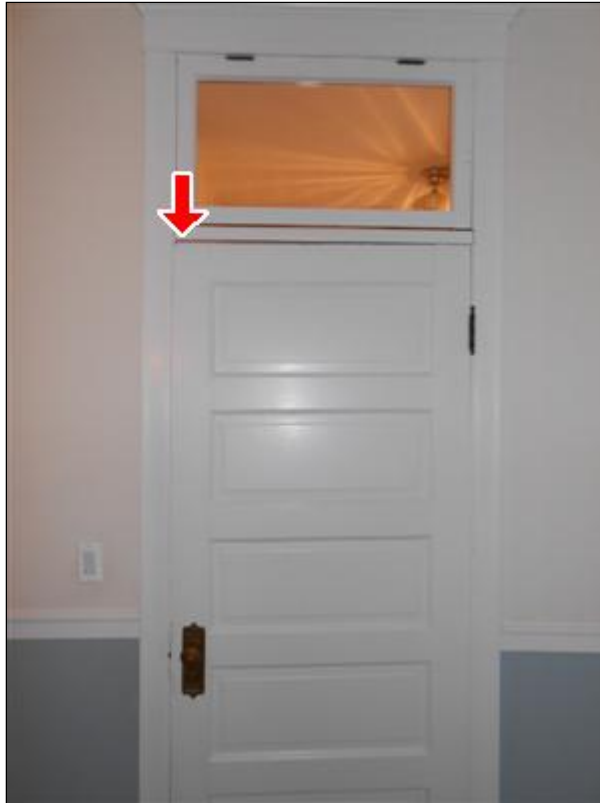
4.5 Picture 1

**4.5** The Entry door needs adjustment rubs at top when closing at the Dining Room. Repairs are needed. A qualified contractor should inspect and repair as needed.

The Entry door needs adjustment rubs at top when closing at the Dining Room. Repairs are needed. A qualified contractor should inspect and repair as needed.

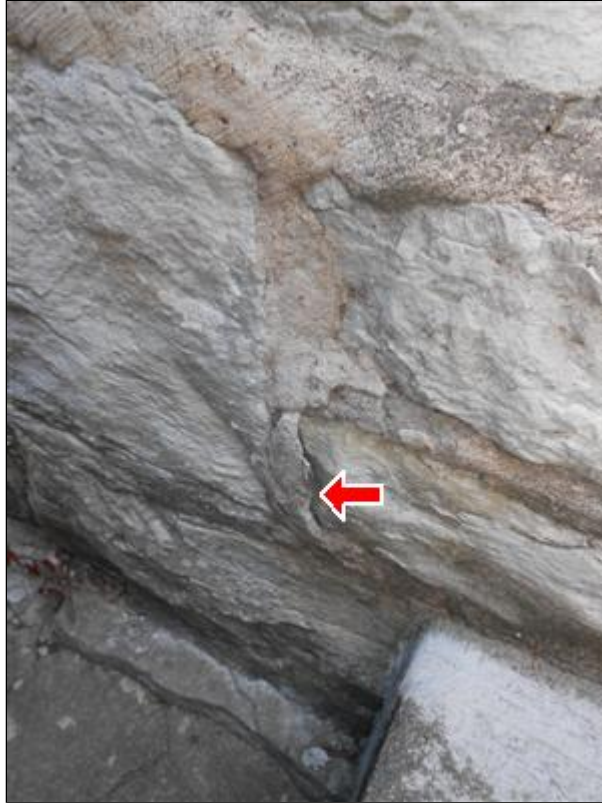
5.0 Picture 1

**5.0** (1) The stone foundation at the front of the home is in need of tuck pointing. Tuck pointing will stop water from entering the the foundation and causing damage. We recommend that a qualified contractor review and repair as needed.

(1) The stone foundation at the front of the home is in need of tuck pointing. Tuck pointing will stop water from entering the the foundation and causing damage. We recommend that a qualified contractor review and repair as needed.

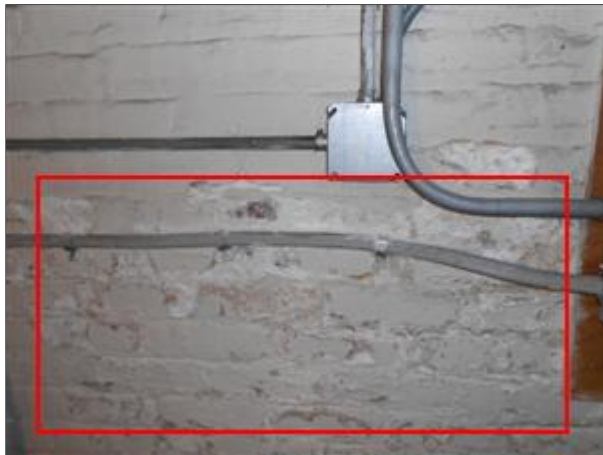
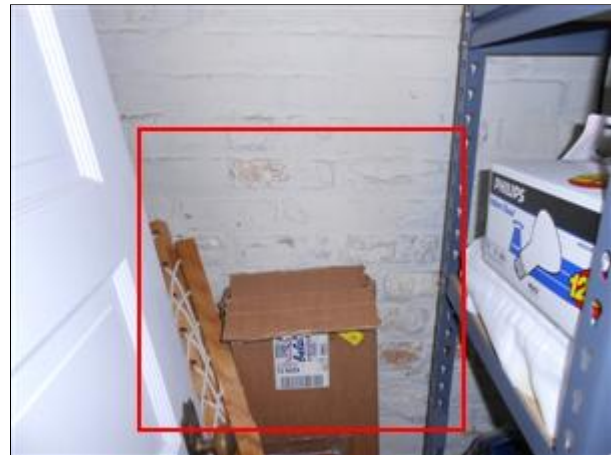
(2) White efflorescence (powder substance) on brick wall indicates moisture is in contact with the masonry. This does not necessarily indicate that intrusion will occur. I recommend checking the gutters and the downspout drain lines for proper operation. Efflorescence is found on many homes without water intrusion occurring inside the home. But, it should alert you to the possibility that future steps may be needed.

(2) White efflorescence (powder substance) on brick wall indicates moisture is in contact with the masonry. This does not necessarily indicate that intrusion will occur. I recommend checking the gutters and the downspout drain lines for proper operation. Efflorescence is found on many homes without water intrusion occurring inside the home. But, it should alert you to the possibility that future steps may be needed.

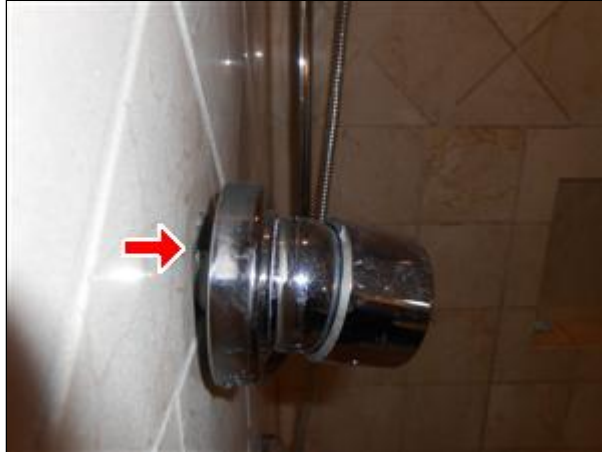
6.1 Picture 1

**6.1** The body sprays in the master shower are missing silicone caulk around the sprayers.this can allow water to enter in behind the tile and cause damage.we recommend that a qualified contractor review and repair as needed.

The body sprays in the master shower are missing silicone caulk around the sprayers. This can allow water to enter in behind the tile and cause damage. We recommend that a qualified contractor review and repair as needed.

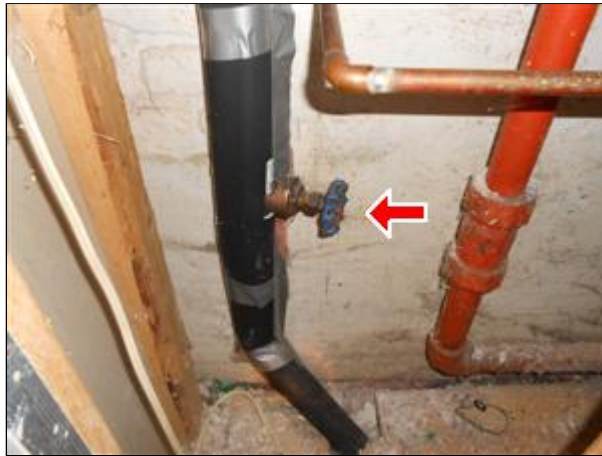
6.3 Picture 1

**6.3** The main shut off is the blue knob located in the basement in the south west corner of the basement. This is for your information.

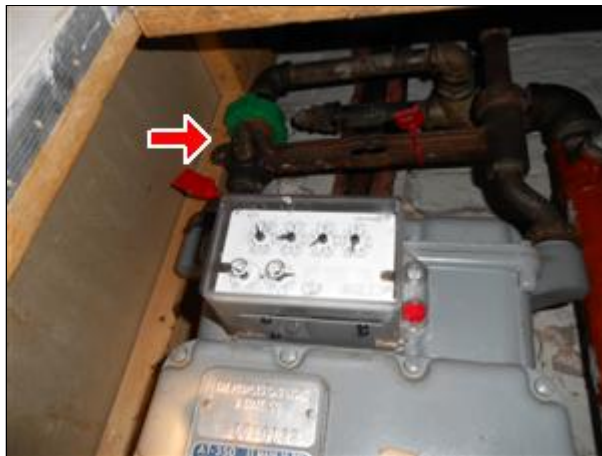
6.5 Picture 1

**6.5** The main fuel shut off is at gas meter in the south west corner of the basement.

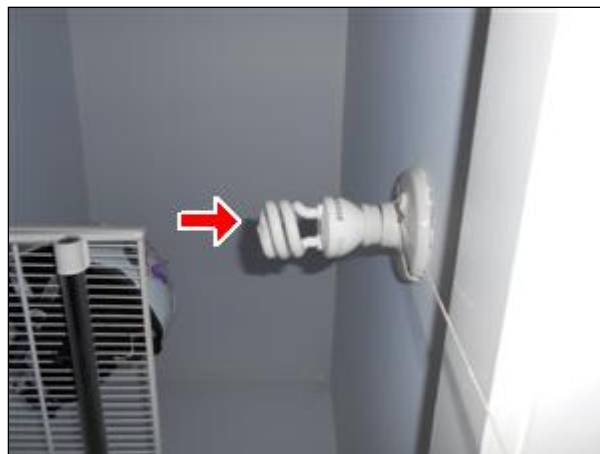
7.3 Picture 1

**7.3** Bare bulbs found in many of the closets. This is a fire hazard and should be repaired. Have reviewed and repaired by a licensed electrician.

Bare bulbs found in many of the closets. This is a fire hazard and should be repaired. Have reviewed and repaired by a licensed electrician.

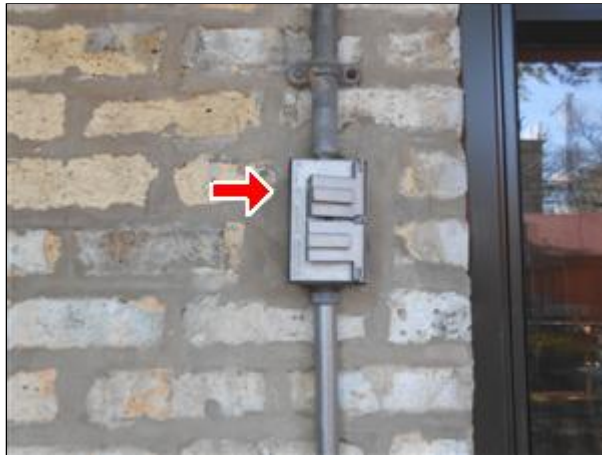
7.4 Picture 1

**7.4 (1)** The exterior outlet at the rear of home are "three-prong" receptacle, and not a "three-prong" GFCI outlet with exterior cover. This is a safety issue that needs to be corrected. A qualified licensed electrical contractor should correct as needed.

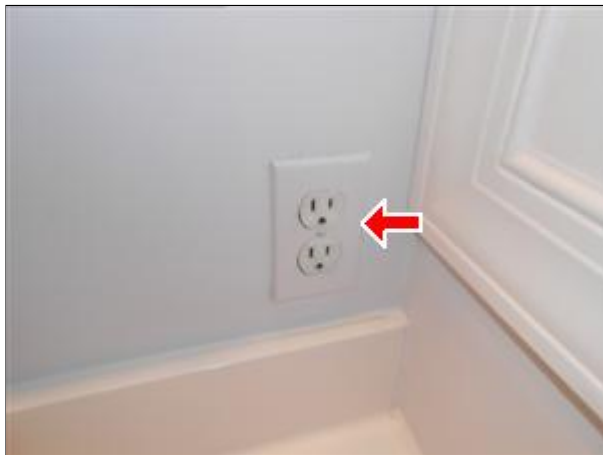
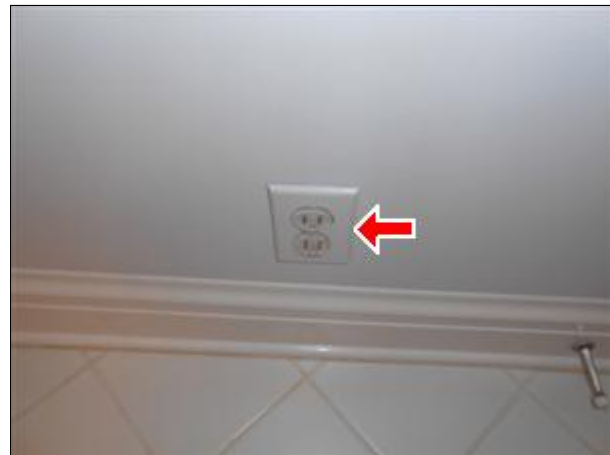
**(2)** At least two "three-prong" outlets are outdated and not a three-prong GFCI (Ground Fault Circuit Interrupt) in the hall bath . This is a safety issue that needs to be corrected. A qualified licensed electrical contractor should correct as needed.

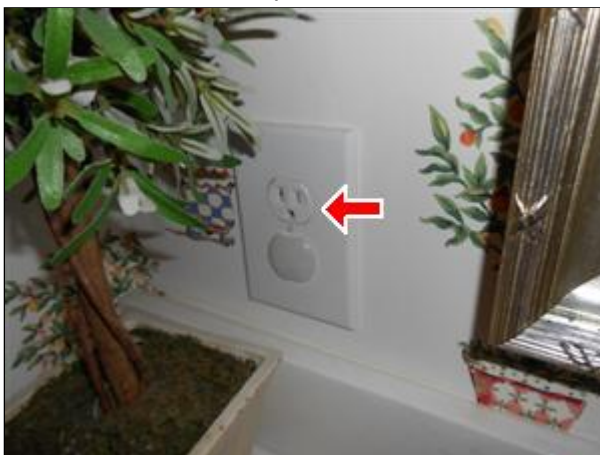
7.4 Picture 4

(3) At least one "three-prong" outlet is outdated and not a three-prong GFCI (Ground Fault Circuit Interrupt) in the powder room. This is a safety issue that needs to be corrected. A qualified licensed electrical contractor should correct as needed.

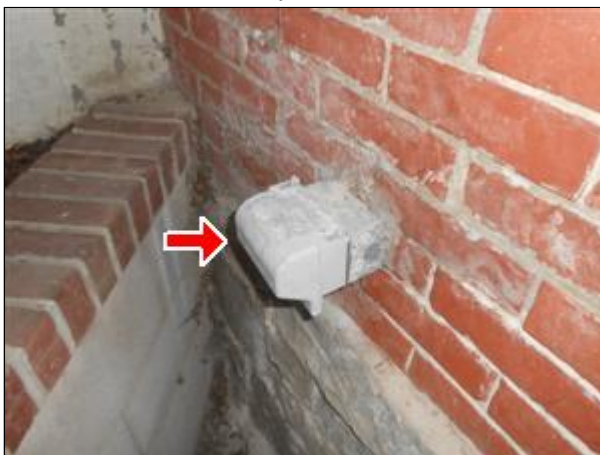
7.4 Picture 5

(4) The exterior outlet at the front of home are "three-prong" receptacle, and not a "three-prong" GFCI outlet with exterior cover. This is a safety issue that needs to be corrected. A qualified licensed electrical contractor should correct as needed.

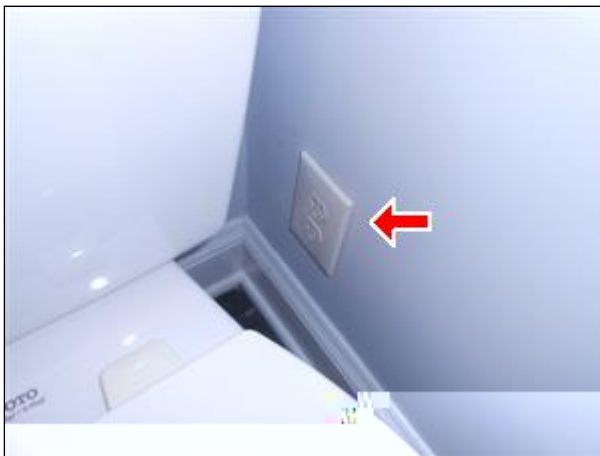
7.4 Picture 6

(5) At least one "three-prong" outlet is outdated and not a three-prong GFCI (Ground Fault Circuit Interrupt) and loose in wall in the lower levels bathroom. This is a safety issue that needs to be corrected. A qualified licensed electrical contractor should correct as needed.

(5) At least one "three-prong" outlet is outdated and not a three-prong GFCI (Ground Fault Circuit Interrupt) and loose in wall in the lower levels bathroom. This is a safety issue that needs to be corrected. A qualified licensed electrical contractor should correct as needed.

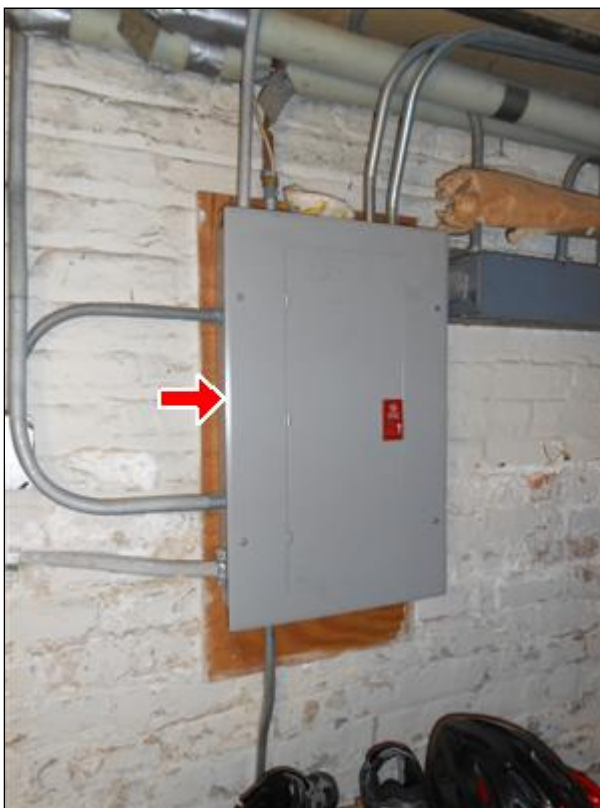
7.6 Picture 1

**7.6** The main panel box is located at the basement furnace room.

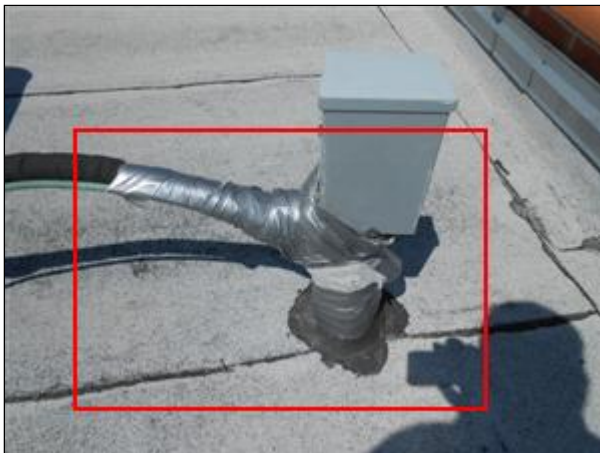
8.8 Picture 1

**8.8** The suction lines for the AC unit on the roof are sealed with duct tape and the duct tape is failing. This is not a properly fix. Repairs are needed. We recommend that a qualified HVAC contractor review and repair as needed.

The suction lines for the AC unit on the roof are sealed with duct tape and the duct tape is failing. This is not a properly fix. Repairs are needed. We recommend that a qualified HVAC contractor review and repair as needed.

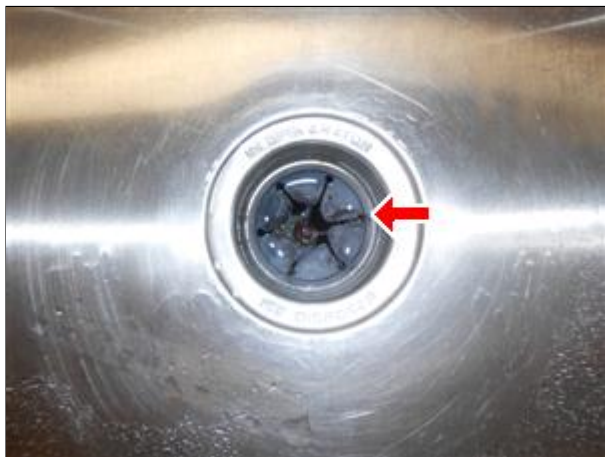
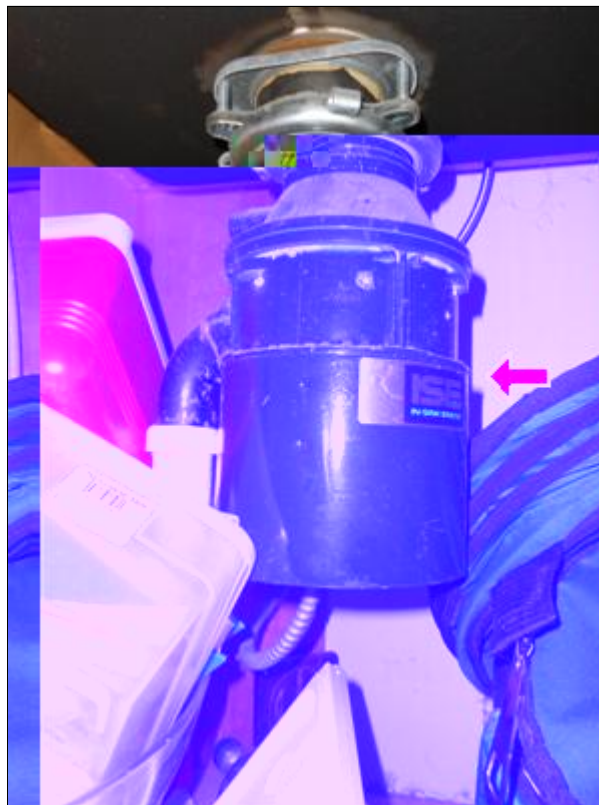
**10.3** The food disposer rubber strainer/guard no longer works as intended and would not operate or non functional at the basement bar sink. I recommend repair as needed.

The food disposer rubber strainer/guard no longer works as intended and would not operate or non functional at the basement bar sink. I recommend repair as needed.
